F. Rapid Intervention Crew and Rescue Operations

Woodscape Drive Incident Overview: Rapid Intervention Crew: RIC and Rescue On July 23, 2018, the Rapid Intervention Crew (RIC) was challenged with the difficult task of locating and attempting to rescue FF Nathan Flynn (Engine 101B) after he fell through a hole in the floor of a burning structure. Prior to the MAYDAY, the Incident Commander assigned Paramedic 56 to Initial Rapid Intervention Crew (IRIC). At 02:18:29, the Incident Commander assigned Truck 7 Rapid Intervention Crew (RIC). Immediately after FF Flynn fell through the hole, Engine 101A pulled on the hose line and Engine 51B reached into the hole in hopes of rescuing FF Flynn. Those efforts were unsuccessful.

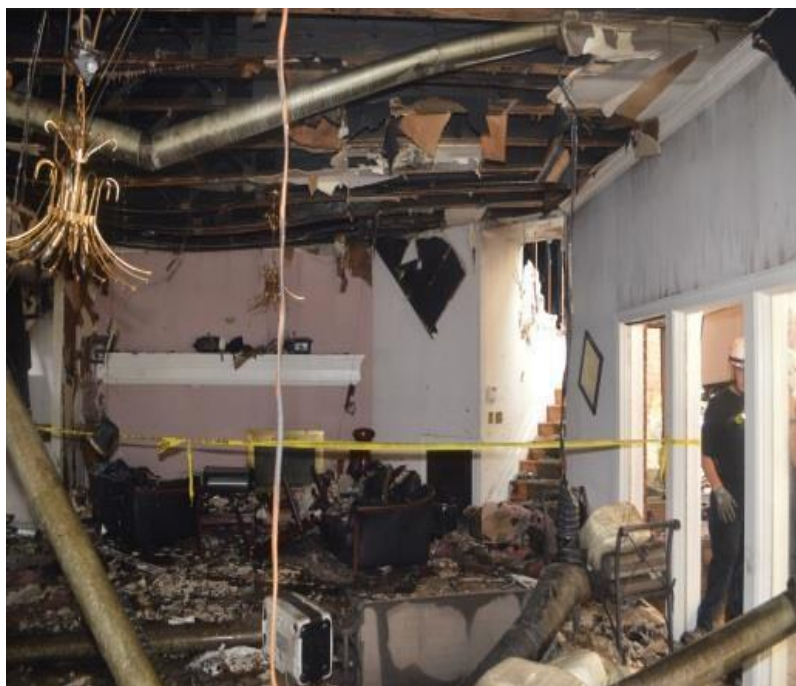
Figure 21 RIT entry door to the right, first steps encountered by RIT, and furniture crews had to work around.

Crews first came across a set of steps that led to the first floor (Figure 21). Truck 7B ascended the steps and found high heat conditions and low visibility. The firefighter descended the steps and continued the search. As crews were moving forward into the basement they encountered furniture in their path (Figure 21), smoke conditions that were described as having a black-oily residue consistency, and a slippery floor potentially from the residue in the air. Truck 7C and Paramedic

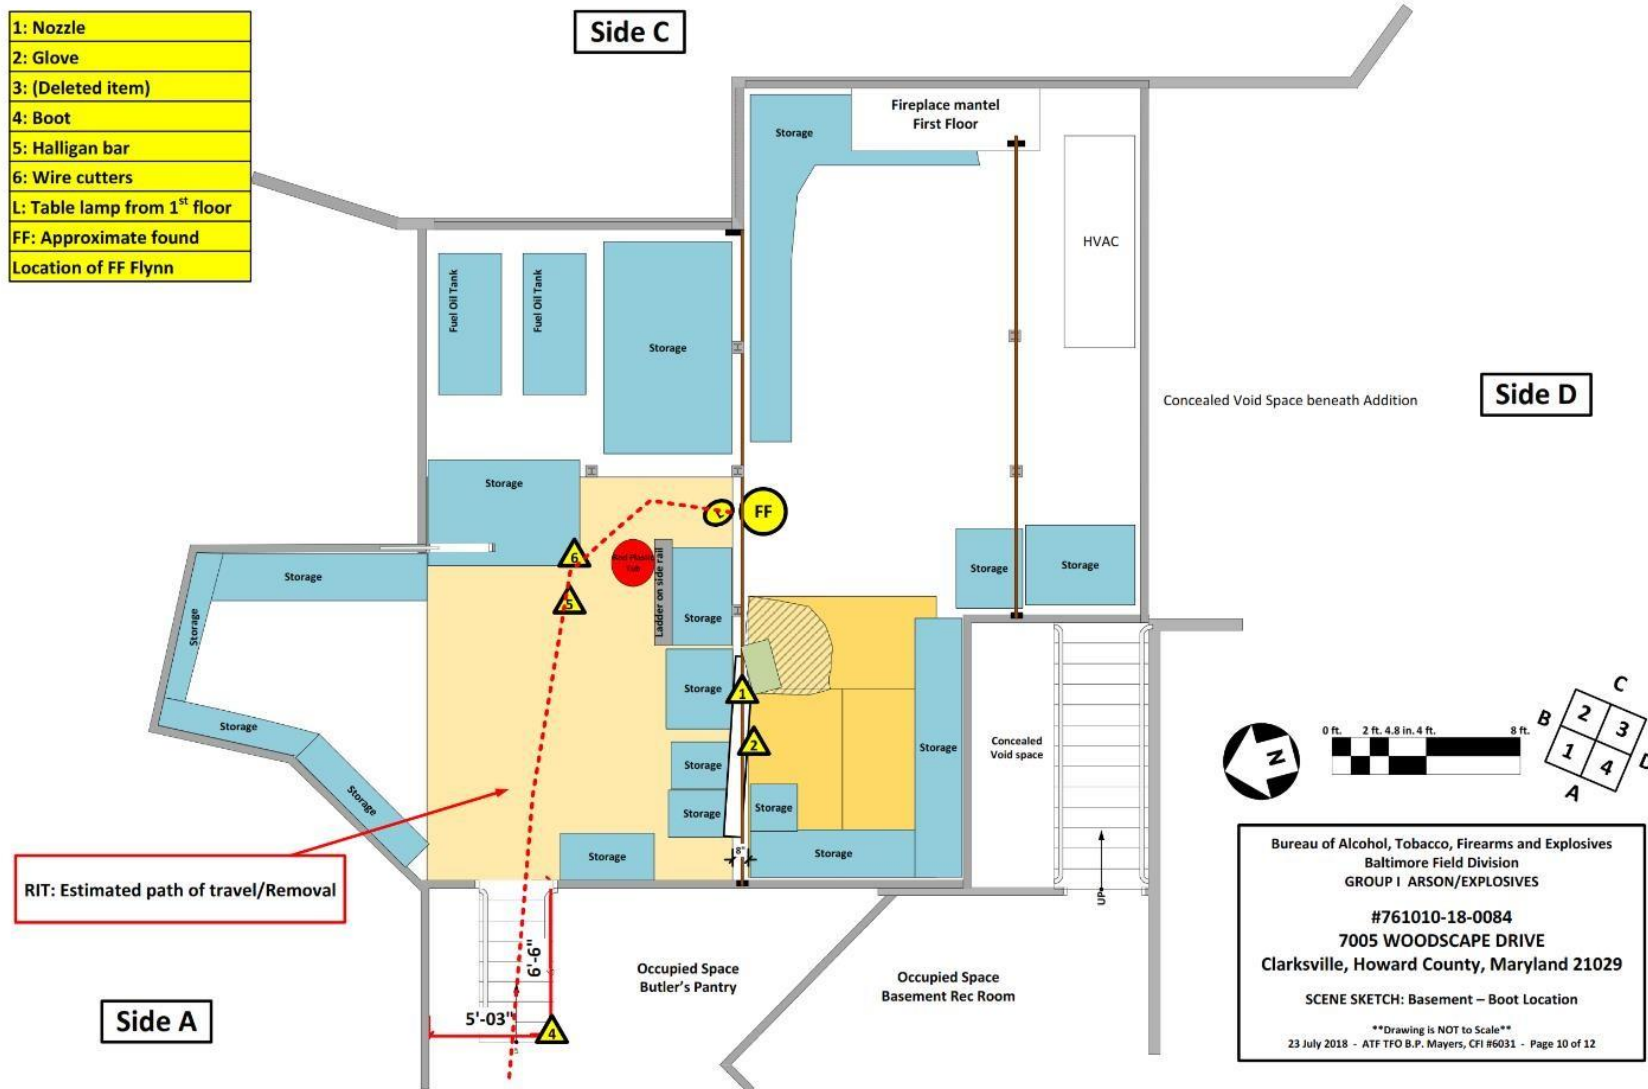
Figure 22 Diagram of RIC Path. Note, Side D on this diagram is incorrectly labeled. It is Side C for the purposes of this report.

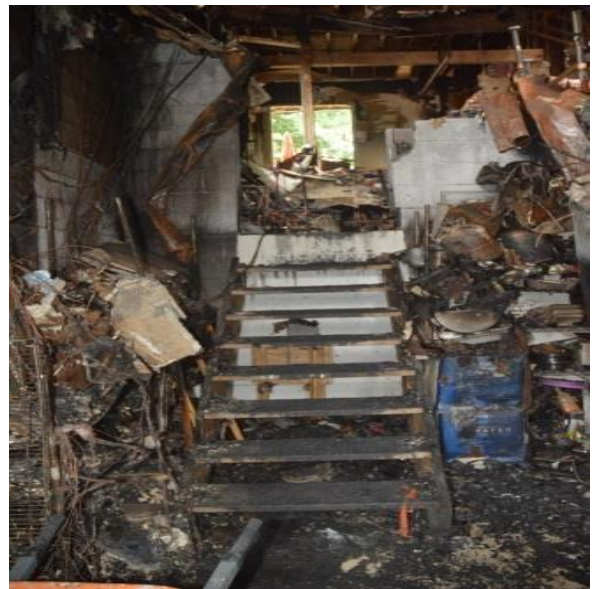
Figure 23 Steps leading from basement to crawl space where FF. Flynn was located

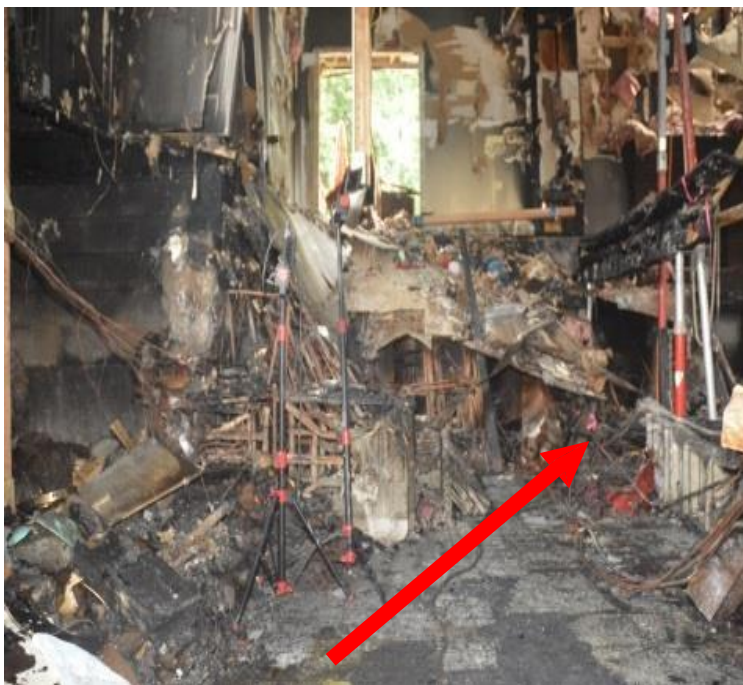
Figure 24 Crawlspace view from top of the steps. FF Flynn located just past folding ladder on other side of beam.

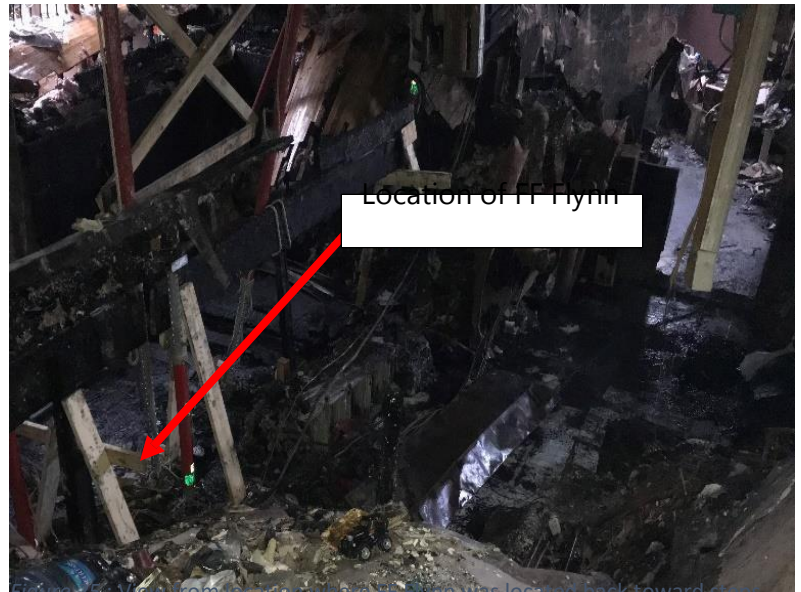
Figure 28 - View from location where FF Flynn was located back toward steps from crawlspace to basement.

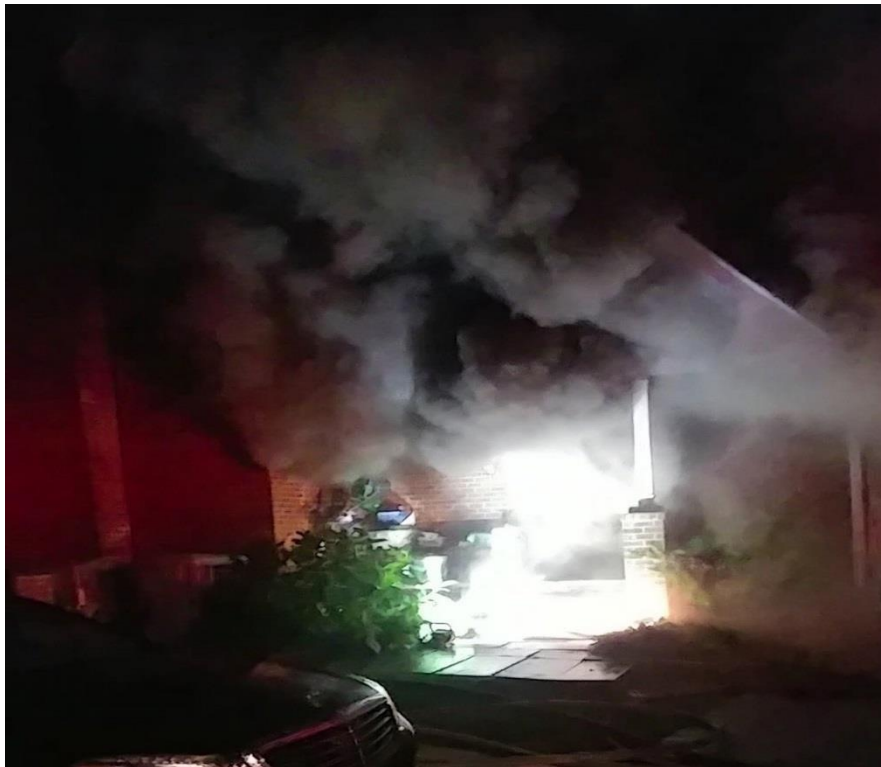
Figure 26 Conditions during RIC Operations from laundry room door (point of entry for FF Flynn).

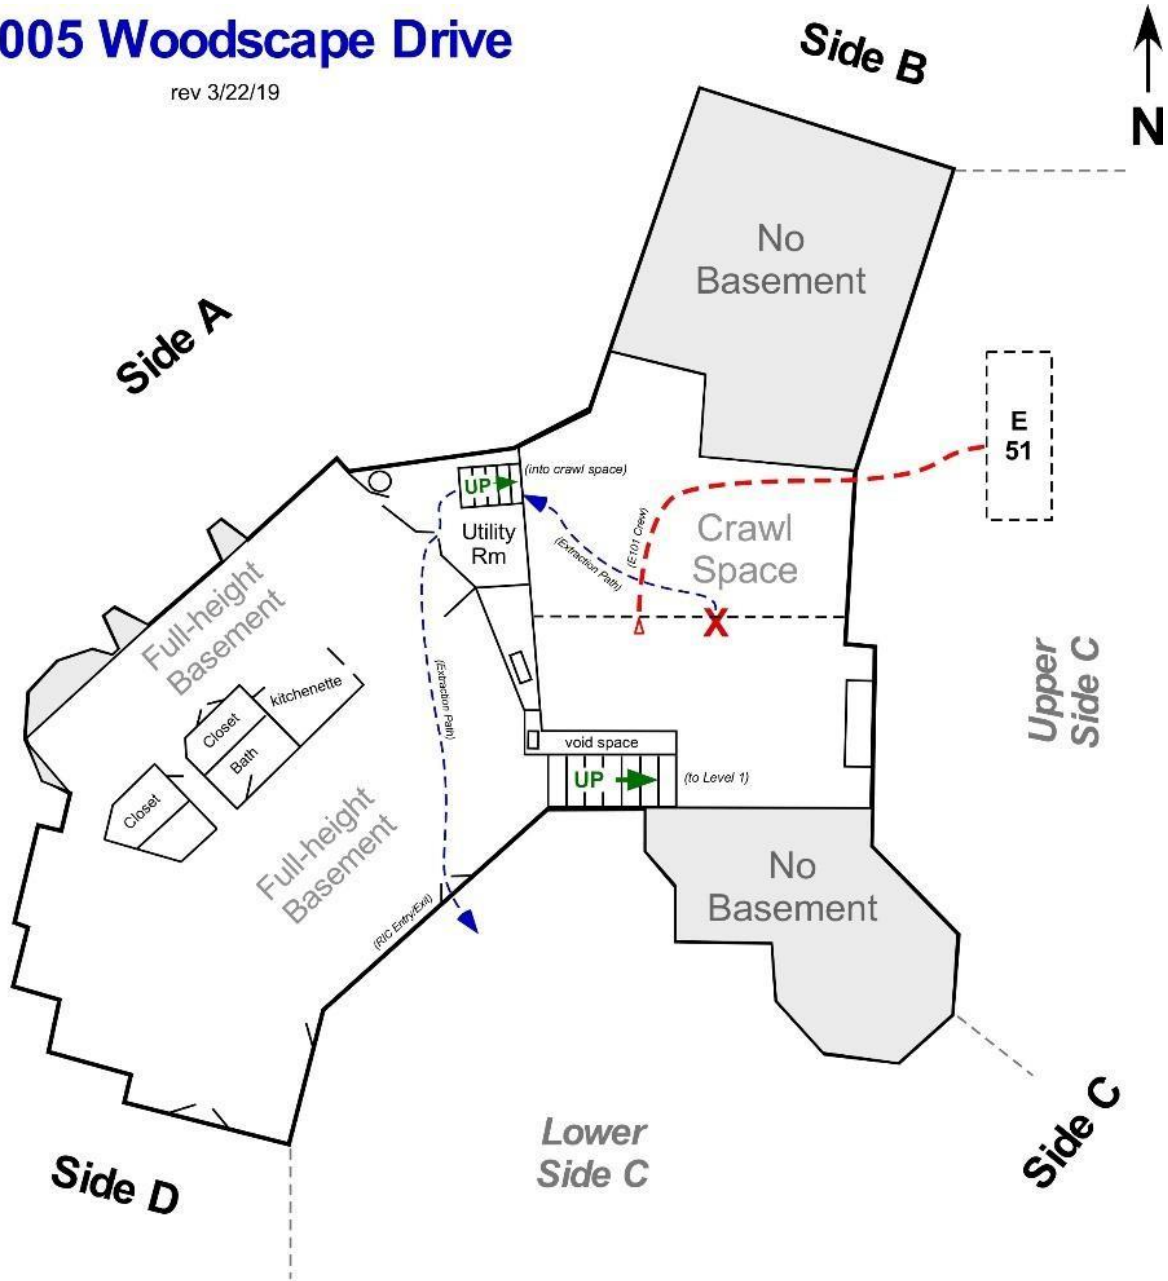
Basement Level

X = Victim Location
